Environmental Assessment
From an
Indoor Air Quality (IAQ)
Perspective

At
3 Valley Road
New Idaho NJ 94T18

By
Sal La Duca
Indoor Environmentalist
Environmental Assay Inc.
792 Green St.
Phillipsburg NJ 08865
www.emfrelief.com

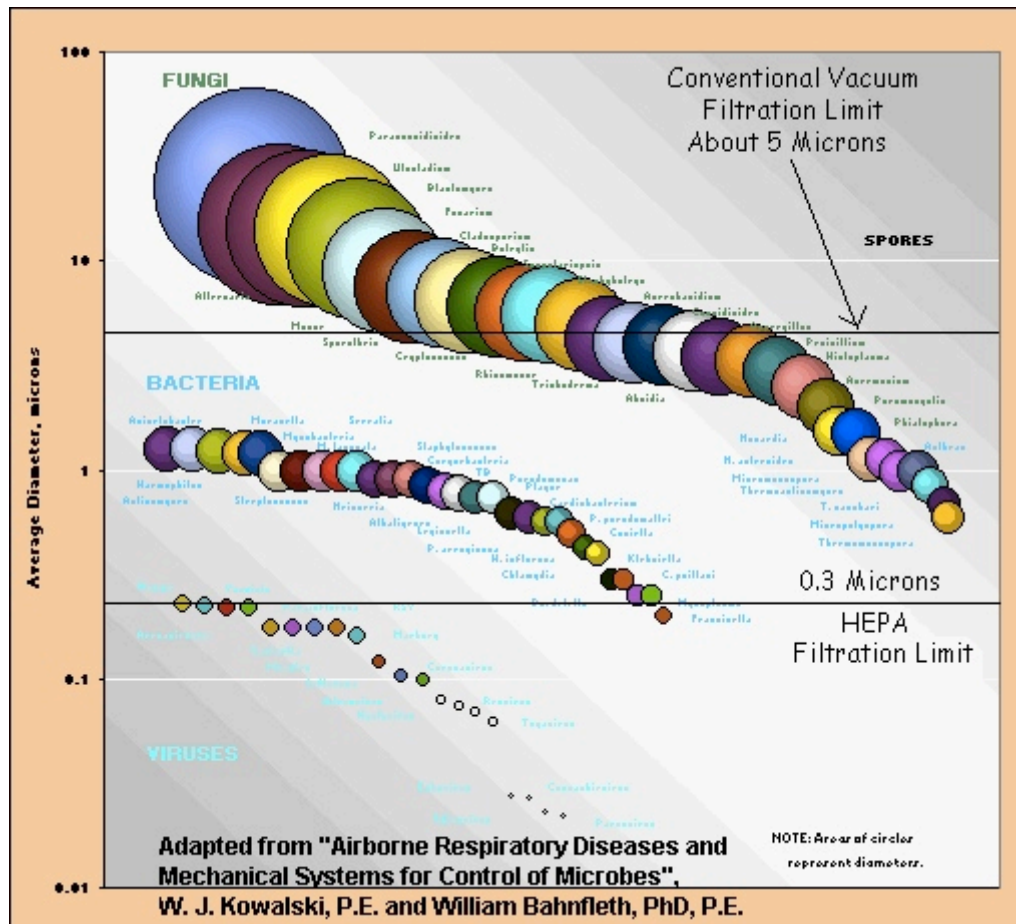
Note from the above that a HEPA vacuum has a very efficient capture level down to 0.3 microns, which includes all pollen, all mold, most bacteria, and inanimate particulates within those size ranges. Even occasional use of such a vacuum will eliminate the possibility of dust buildup (as within carpeting) that could potentially foster mold growth, regardless of the fact that the RH would have to be elevated high enough to support growth, as **molds need a food reservoir – lots of moisture – and relative darkness (sunlight reduces their life expectancy due to the UV). These conditions not existing indicates that any detected mold were simply a reflection of mold exchanged with outdoors in the process of opening the door to come in or go out, or open windows.**

The Birds have and use, a High Efficiency Particulate Air (HEPA) vacuum cleaner.
